QTR-2191-001

QUALIFICATION TEST REPORT FOR
450 GALLON CRASHWORTHY FUEL TANK
FOR
U.S. AIR FORCE H-53 HELICOPTER

QTR-2191

CRASH IMPACT TEST

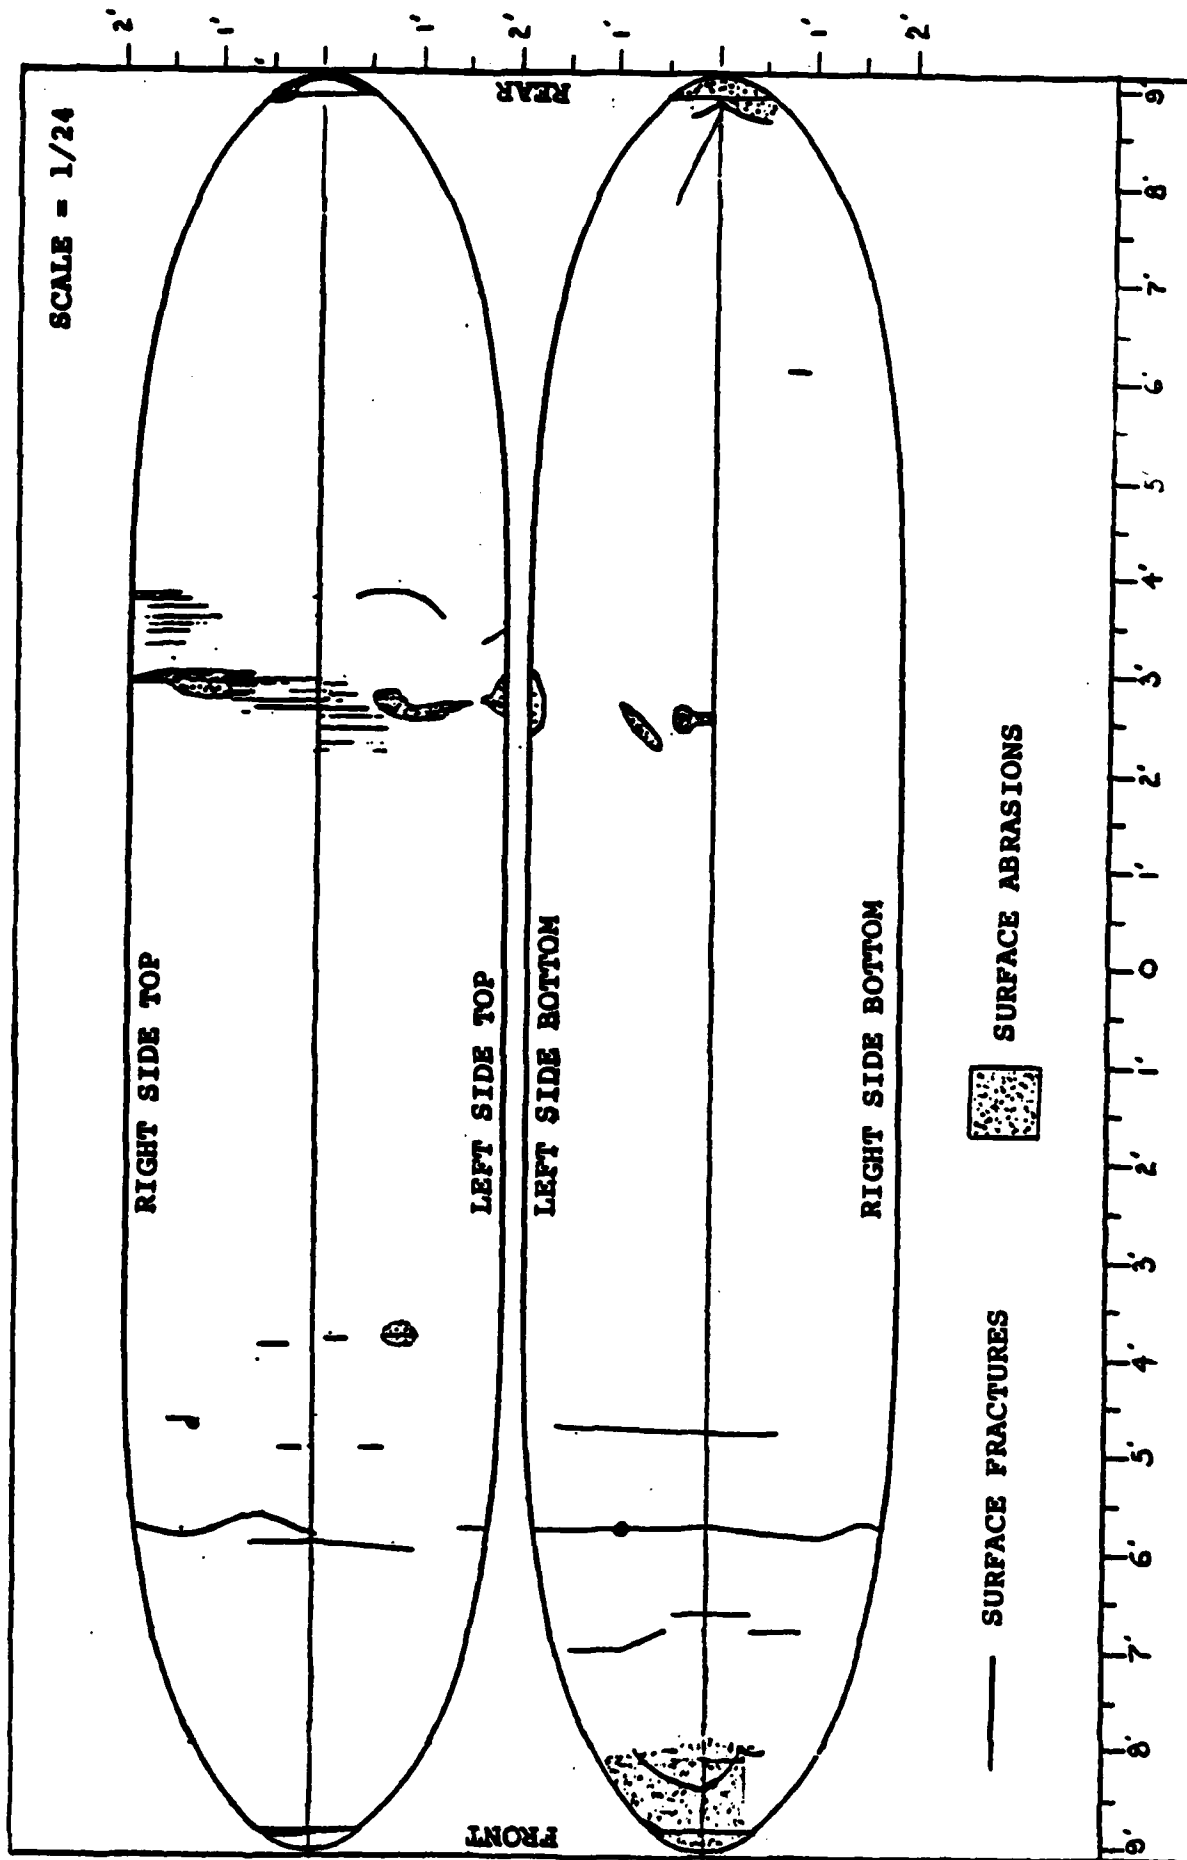
FIGURE 3-4. FUEL TANK SN0003 NON-RUPTURE SURFACE DAMAGE SKETCH.

Although the tank did not separate in pieces, its overall post-test appearance is poor. There is a significant circumferential rupture behind the pylon over the top of the tank. The nose cap is partially extruded from the front of the tank, there are jagged fractures on the underside of the tank nose and tail (the front is also partially ruptured), and there are several shallow fractures around the tank forward of the pylon. The tail cap is destroyed. However, it should be noted that a pressure transducer was cantilevered out of the end cap, approximately 6 inches beyond the end of the tank, and, due to the impact attitude, was the first object to contact the ground. This no doubt exaggerated the damage to the tail cap. Surface damage includes severe scuffing on the bottom and left side of the tank.

The impacted area of the tank includes both the bottom and left side of the tank. Majority of damage aside from ruptures and fractures consists of scuffing which exposed the yellow primer paint and circumferential windings. Near the drain plug and along the left side there are deeper scuffs exposing the graphite windings. On left side of tank, approximately even with the front of the pylon, there is a deep scuff down to helical glass/epoxy windings. Near the primary rupture there are several surface delaminations.

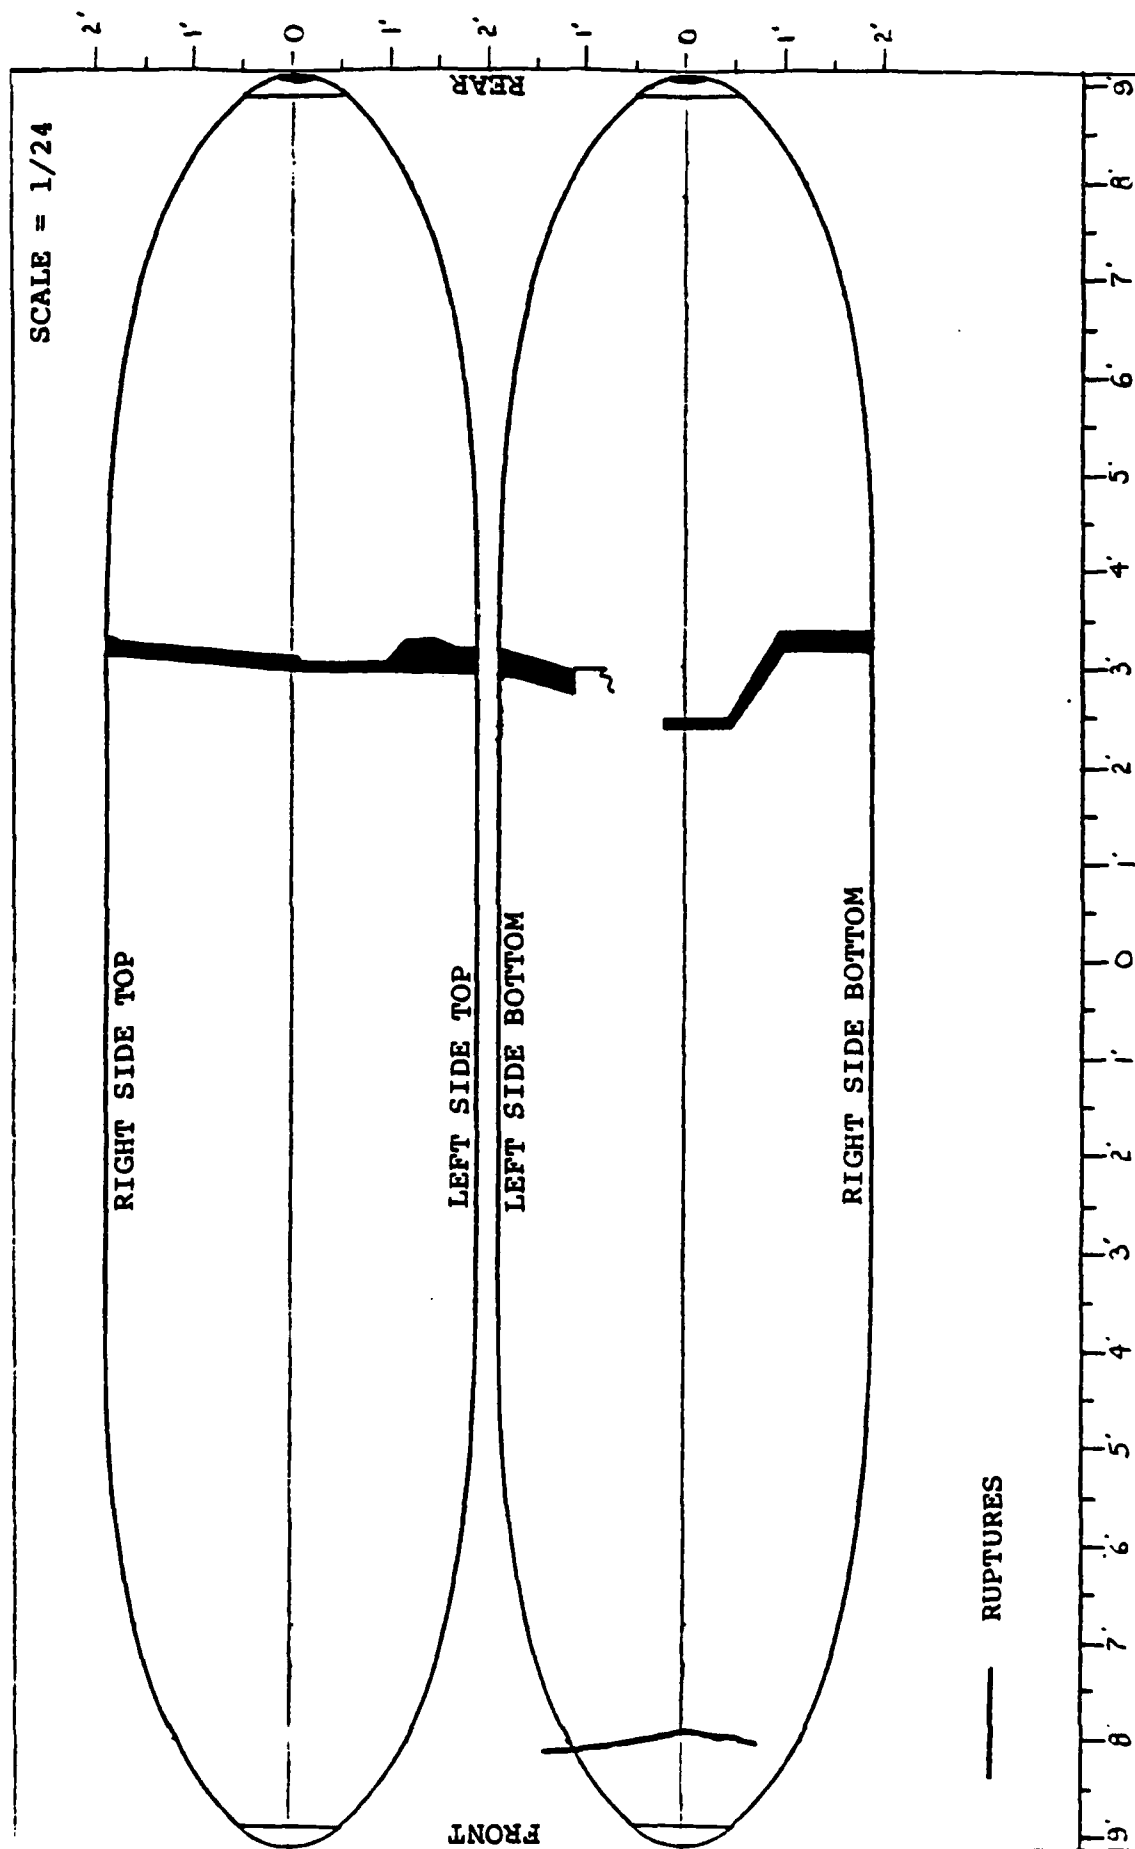
FIGURE 3-11. FUEL TANK SN0003 RUPTURE LOCATION SKETCH.

Three rupture locations were noted. Figure 3-11 is a scaled sketch of the rupture locations.

1. Approximately 8.0' forward of tank center point on bottom.
2. Approximately 3.0' aft of tank center point around top of tank.
3. Approximately 9.0' aft of tank center point on tip of tail.

1. Jagged tearing failure of helical windings at front underside of tank. All layers down to thermoplastic exposed. Rupture extends approximately one-half tank circumference.
2. Complete split of tank around seven-eighths of circumference. All layers exposed. Pieces of honeycomb and thermoplastic protruding to surface. Primarily a failure of helical windings, but circumferential winding tear noted on right side. Rupture runs over top of tank. Severe damage to circumferential windings near rupture.
3. Rupture 3 is a hole in the tip of the tail cap, and may have been aggravated by the pressure sensor which was accessed through the tail cap. The material of the tail cap has suffered extensive compressive damage.

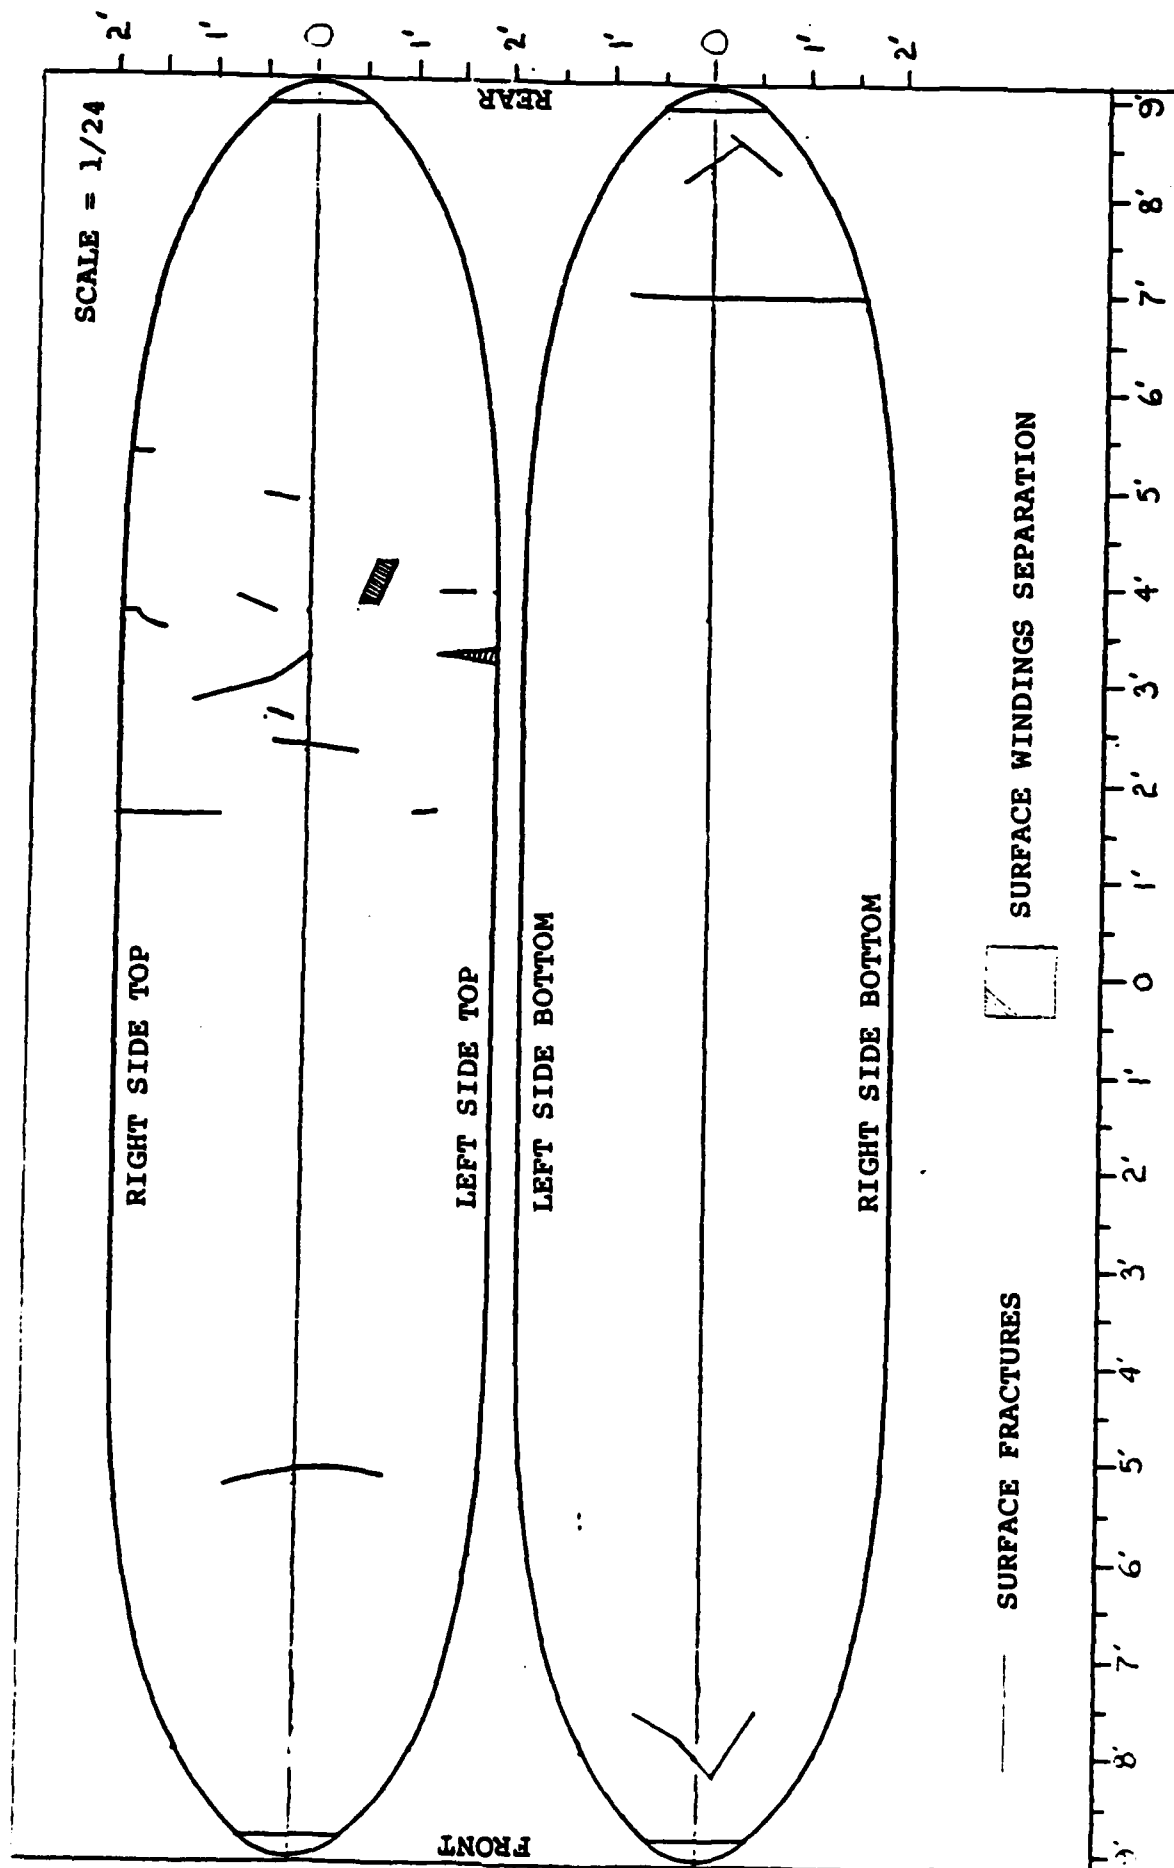
FIGURE 3-18. FUEL TANK SN0004 NON-RUPTURE SURFACE DAMAGE SKETCH.

There are some stress fractures on the top and sides of the tank. Additionally, there is a non-rupture circumferential fracture on the bottom of the tank towards the rear. At both the front and rear of the tank, on the bottom near the end caps, there are "V"-shaped stress fractures. Figure 3-18 is a scaled sketch of all tank surface non-rupture damage. Figures 3-19 and 3-20 show the "V"-shaped fractures at the front and rear of the tank, respectively.

From an overall standpoint, there appears to have been virtually no failure of circumferential windings. Nearly all failures occurred in the helical windings. The ruptures were all on the bottom surface of the tank.

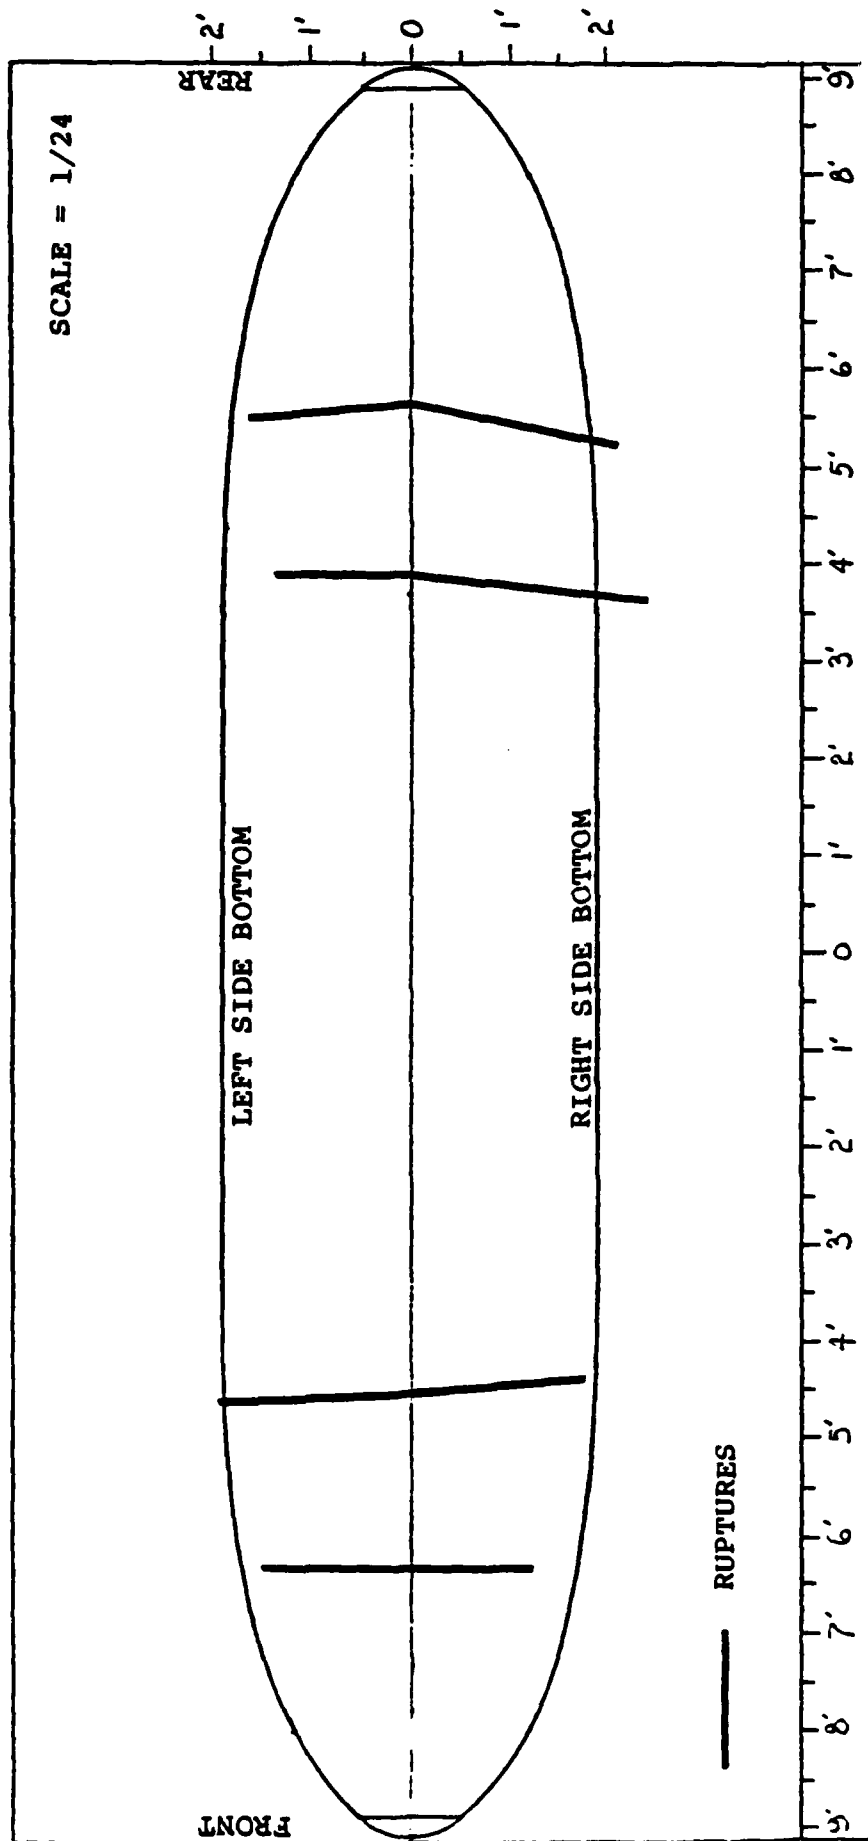
FIGURE 3-21. FUEL TANK SN0004 RUPTURE LOCATION SKETCH.

Four leakage locations were noted. Figure 3-21 is a scaled sketch of the rupture locations.

1. Approximately 6.5' forward of tank center point on bottom.
2. Approximately 4.5' forward of tank center point on bottom.
3. Approximately 3.5' aft of tank center point on bottom.
4. Approximately 5.5' aft of tank center point on bottom.

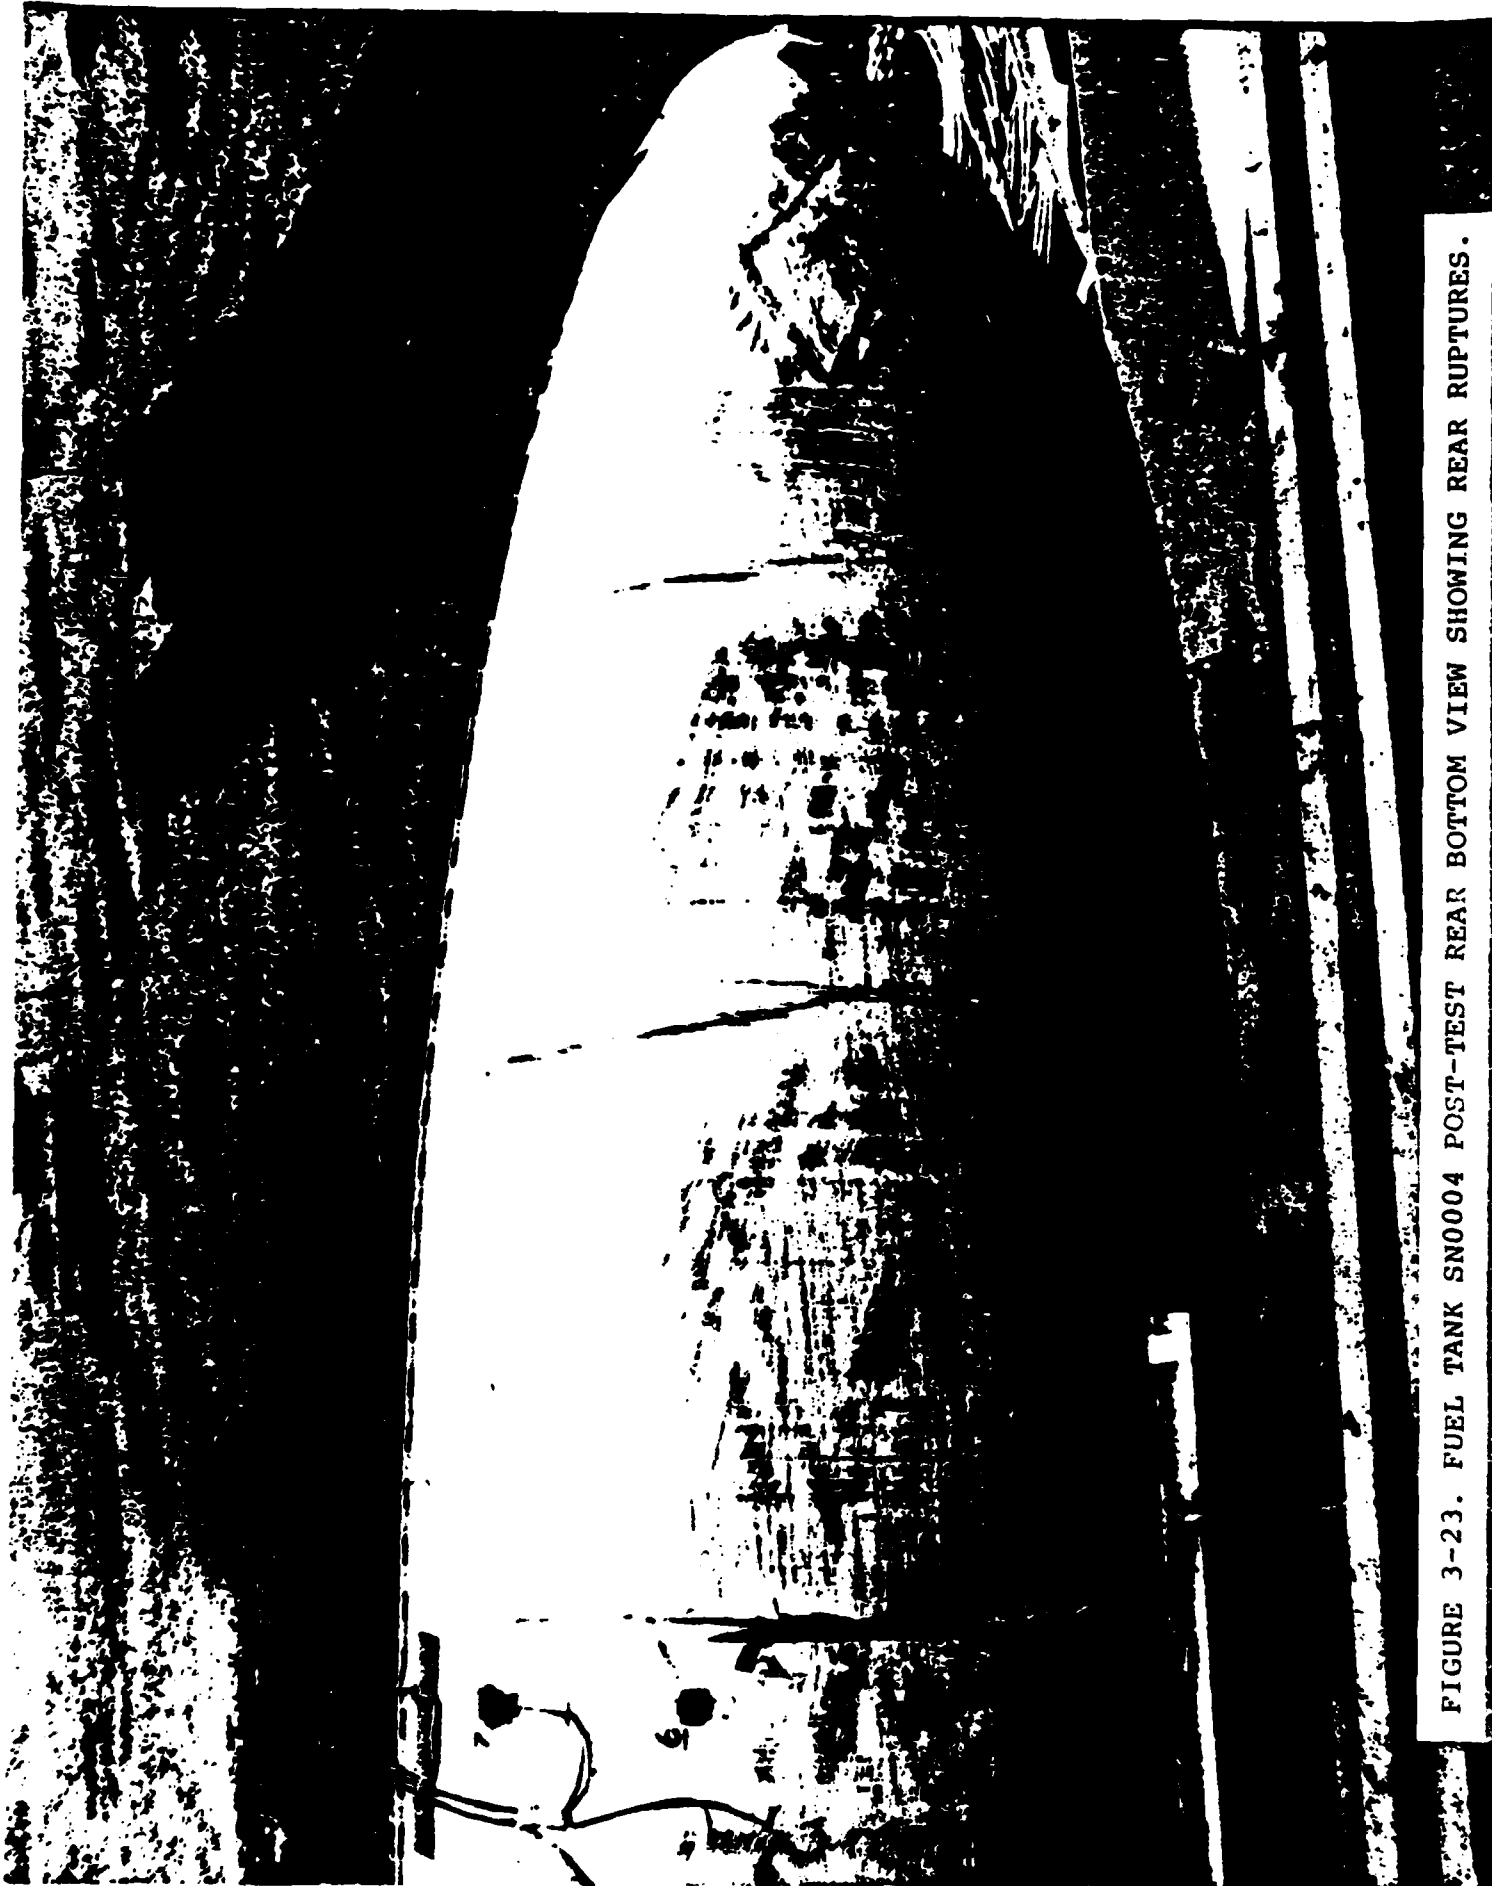
FIGURE 3-23. FUEL TANK SN0004 POST-TEST REAR BOTTOM VIEW SHOWING REAR RUPTURES.

Figure 3-22 shows the forward underside of the tank including ruptures 1 and 2. Figure 3-23 shows the aft underside of the tank including ruptures 3 and 4. Figure 3-24 is a close-up view of rupture 2. Figure 3-25 is a close-up view of rupture 3.

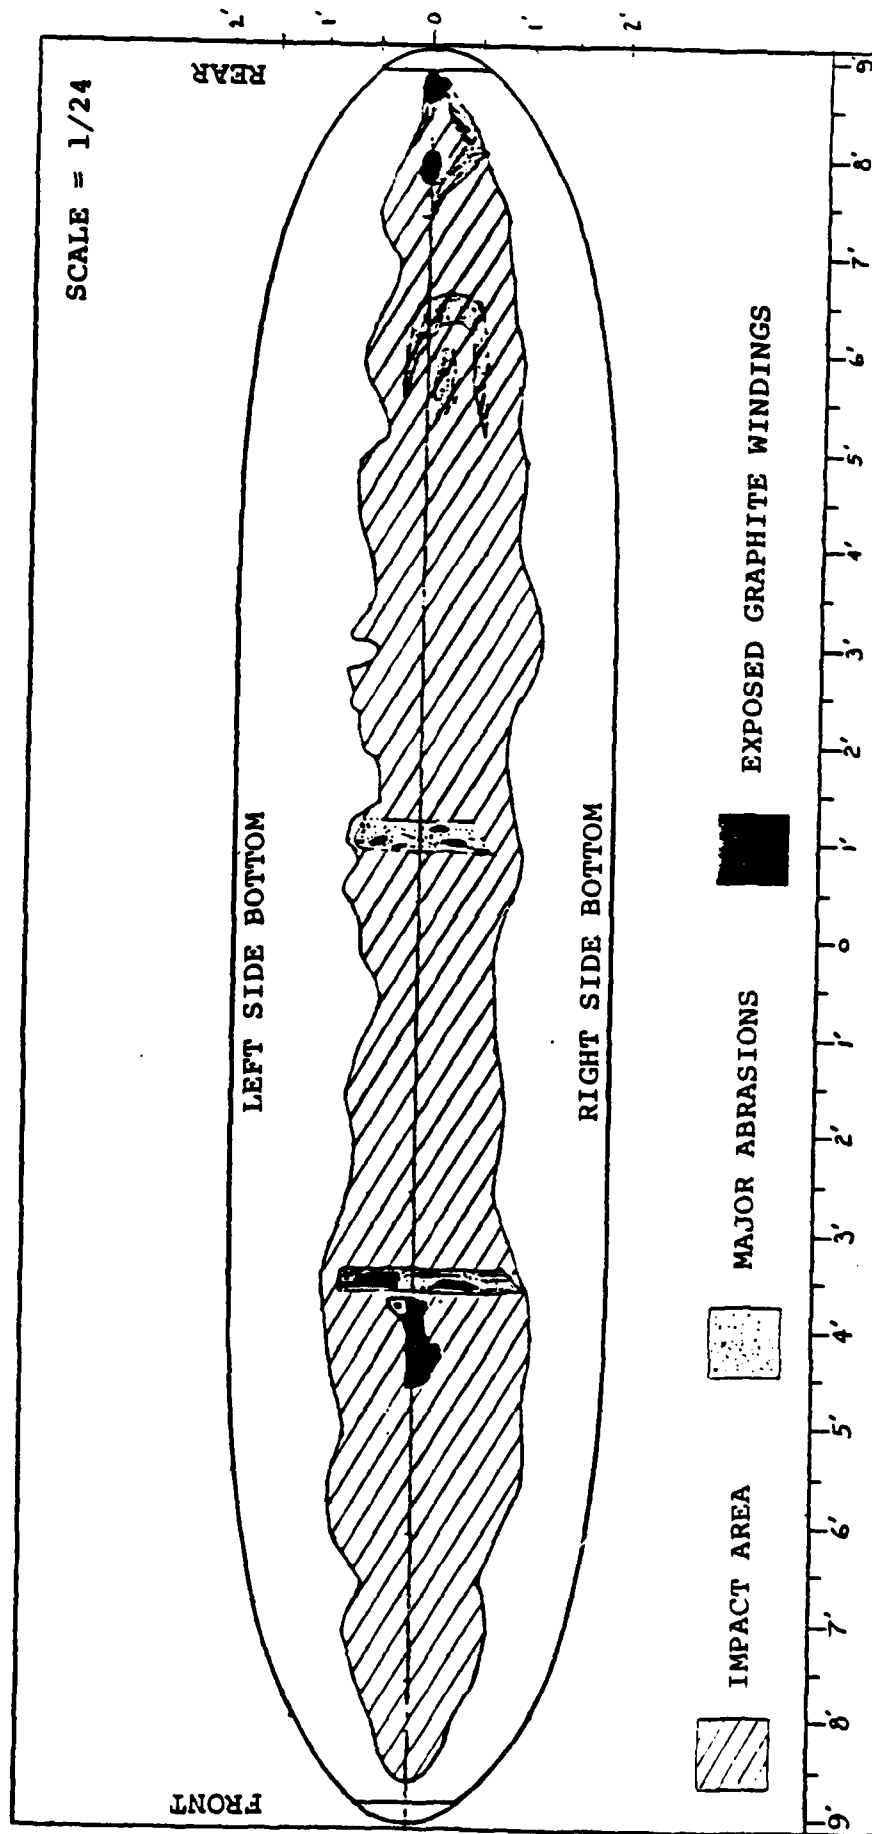
FIGURE 3-26. FUEL TANK SN0004 IMPACT IMPRINT SKETCH.

Besides previously described ruptures and fractures, entire bottom surface of tank is scuffed, primarily only to top layer of glass/epoxy windings, exposing either yellow or pink primer paint and the top layer of glass/epoxy windings. Black graphite windings exposed in several places, most notably near drain plug and near tail cap. No tearing of circumferential winding noted. Figure 3-26 is a scaled sketch of the impact imprint. Figure 3-27 shows an overall view of the bottom of the tank. Previous Figures 3-19, 3-20, 3-22, 3-23, 3-24, and 3-25 also document the impact area.
